Reliability Visual Inspection

Rod's Japanese Auto Care
2009 Subaru Tribeca

VIN: 4S4WX97DX94405304
 Odo: 164,217 miles
 RO#: 38225 03/10/2021

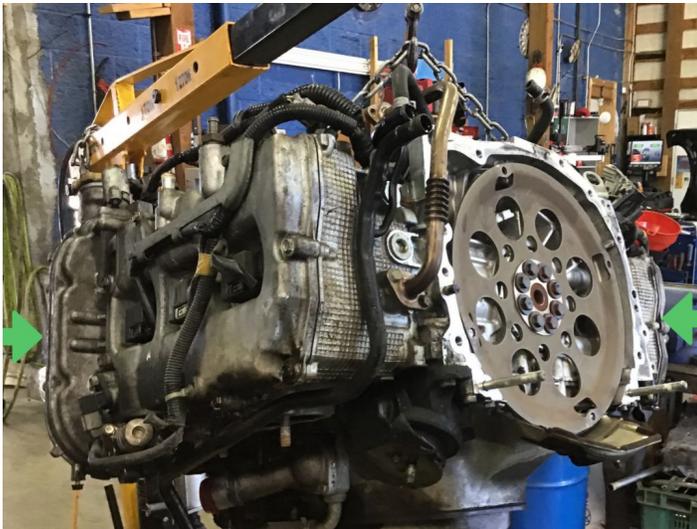
Replace Engine
removing the engine, in process!

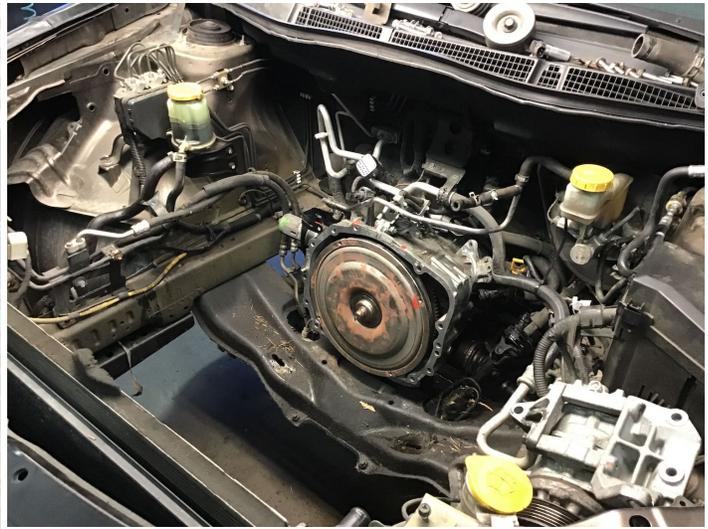
Replace Engine
engine is out!

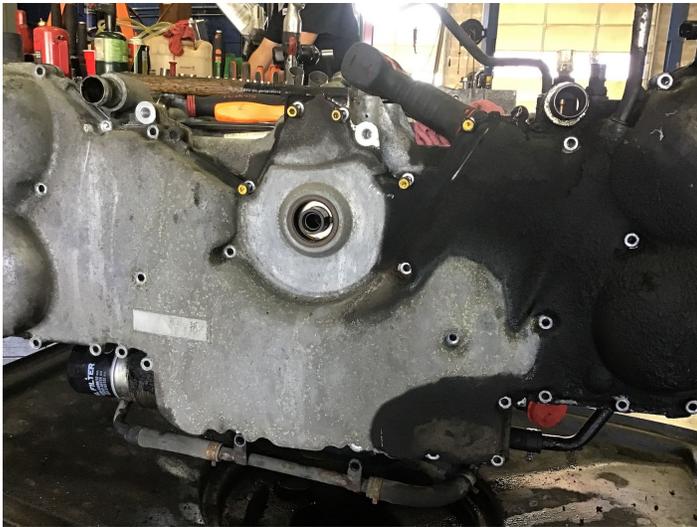
Replace Engine
This is the front of the engine, the
timing chain is under this huge front
cover !

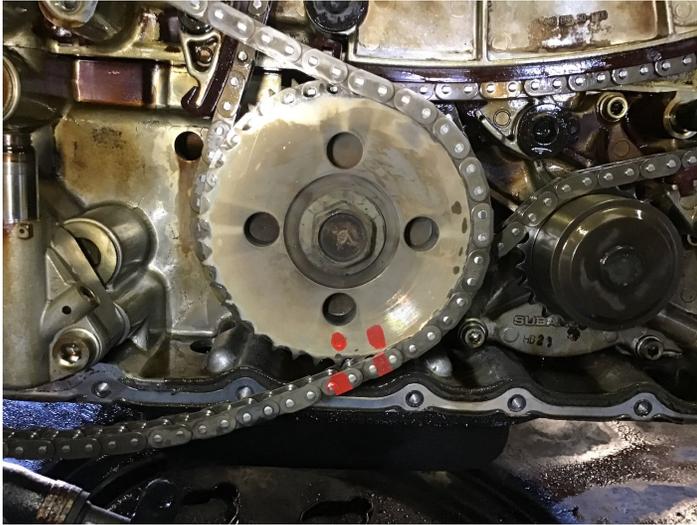
Replace Engine
timing chain marked

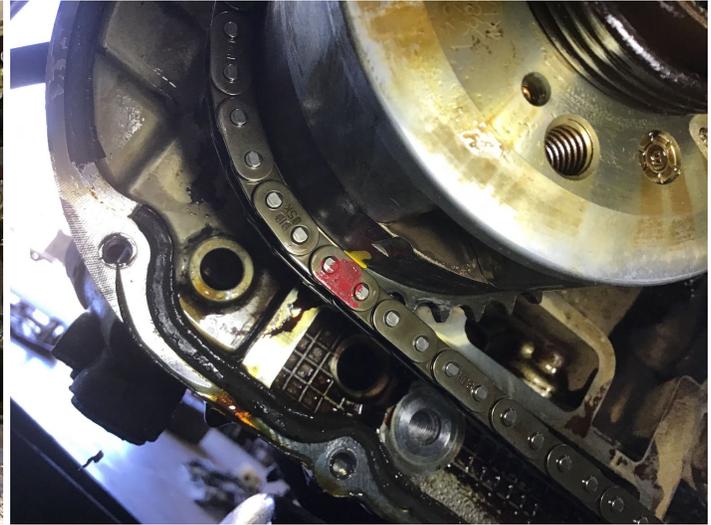
Replace Engine
marked timing chain on gears

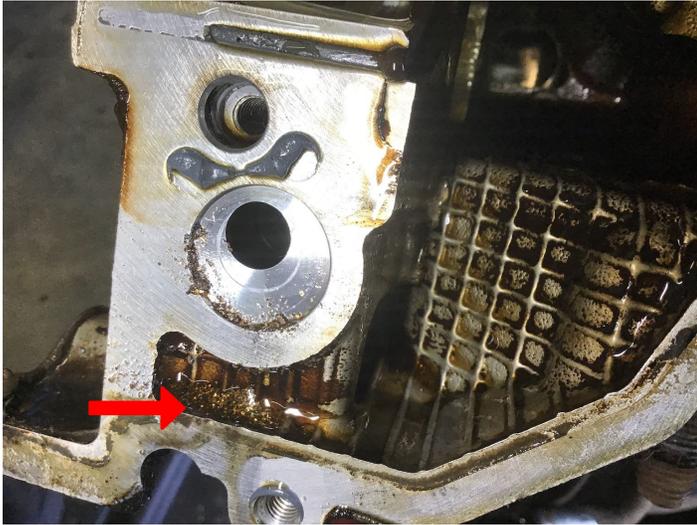
Replace Engine
looking inside the cylinder head here
with valve cover off!

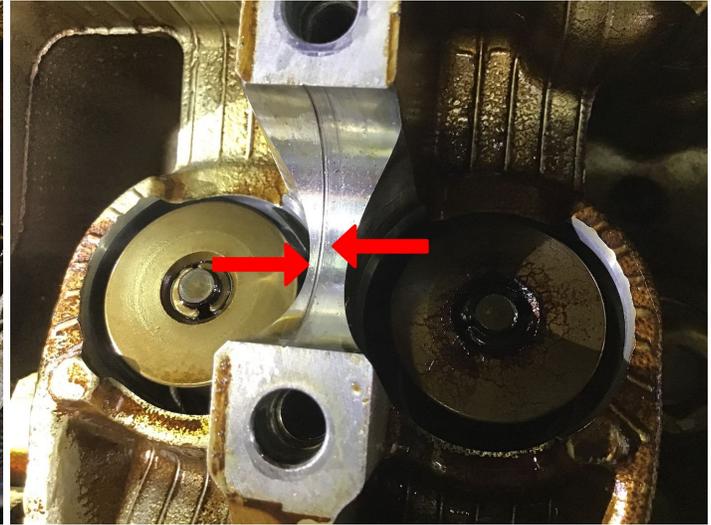
Replace Engine metal from old engine failing

Work Performed: Place vehicle on lift. Remove necessary shields and covers to gain access to the engine. Drain oil and coolant, Remove Driveshafts as necessary. Remove Exhaust down pipes, shifter linkage and all necessary bolts to remove engine. Swap all motor mounts, manifolds and all accessories and put on the new engine with all new gaskets related to it. Reinstall Engine and all bolts and covers. Fill with new fluids. Start engine and run for 5 minutes, inspect for any leaks. None found, test drive for 5 miles rechecked for leaks, all looks good at this time.

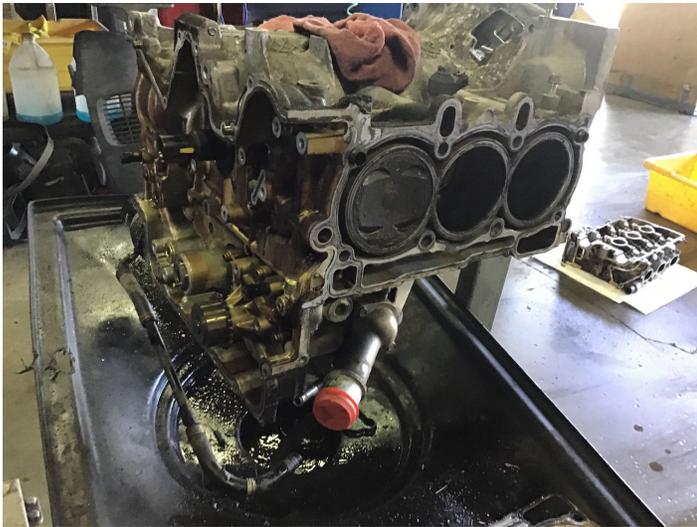
Replace Engine This scored line should NOT be here, we need to also replace the cylinder heads.

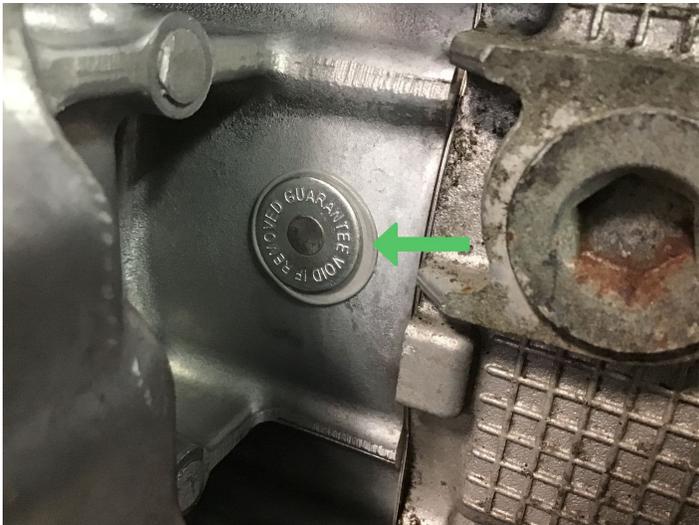
Replace Engine heat tab installed! if this melts or distorts it will void warranty (when that happens it means the engine overheated)

We installed a heat tab that will tell us if the engine ever gets over heated after this repair work- if heat tab is ever melted or dis-torted the warranty is VOID (we took a photo of it)

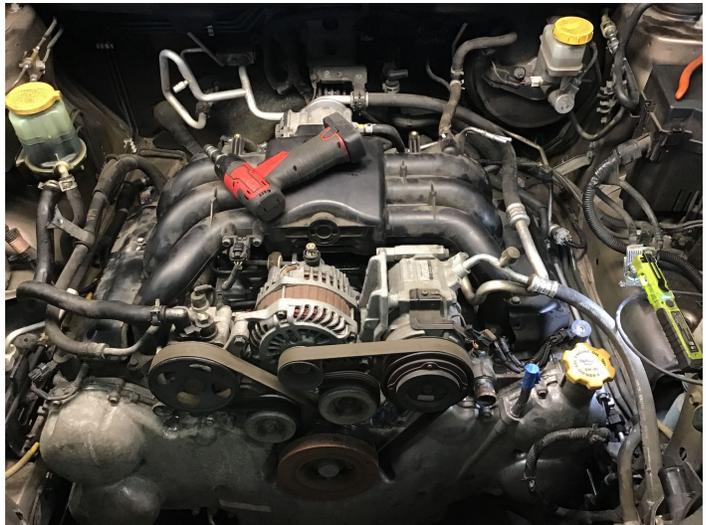
Replace Engine other side heat tab installed

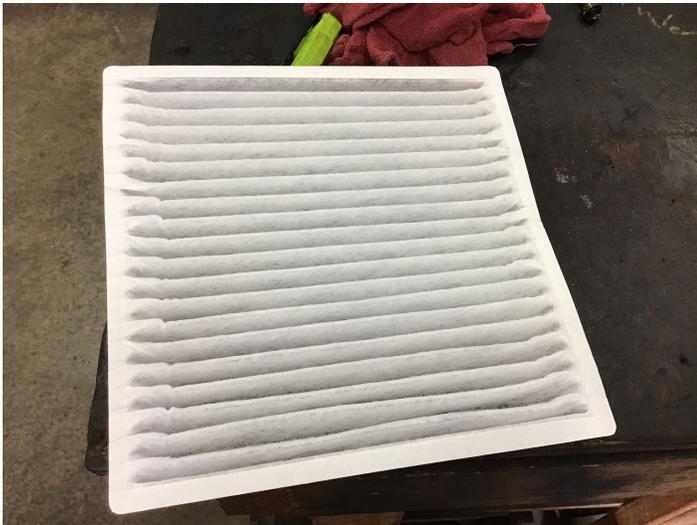
Cabin Filter - REPLACE
A rodent was definitely in this HVAC
box at one point!

Removed the needed covers and trims and the old filter. Cleaned the filter cavity and reassembled with a new filter.

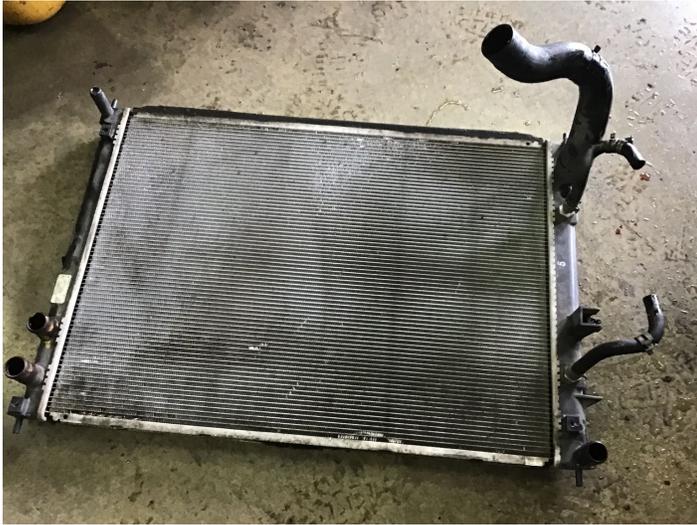
Radiator Replace
old leaky radiator

Work Performed: Place Vehicle on lift. Remove necessary shields to gain access to the Radiator Drain, Drain Radiator. Remove Necessary Shrouds and Shields to gain access to the Radiator Mount bolts. Remove Radiator. Replace with New Radiator and hose clamps as necessary. Fill with fresh engine coolant, Check for leaks. Replace all necessary shields and shrouds. Run engine to operating temperature make sure coolant flow is good and the cooling fan cycles on. Test drive and re-check for leaks. None Found

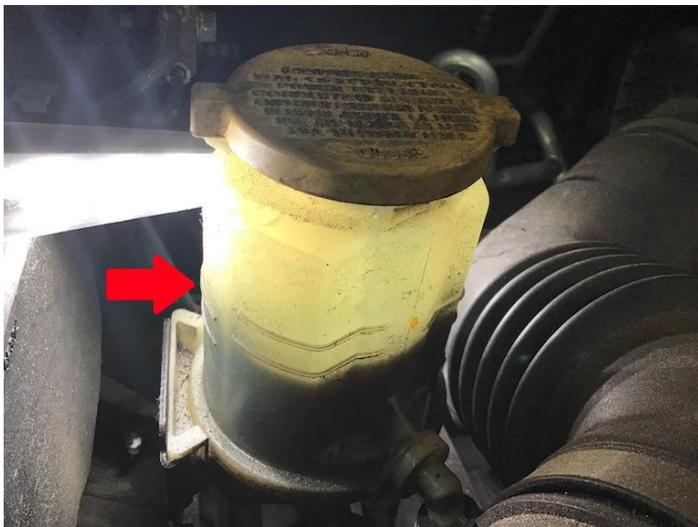
Power Steering Fluid Condition
 this is your power steering fluid reservoir . Your power steering fluid was found contaminated, leaking, and low.

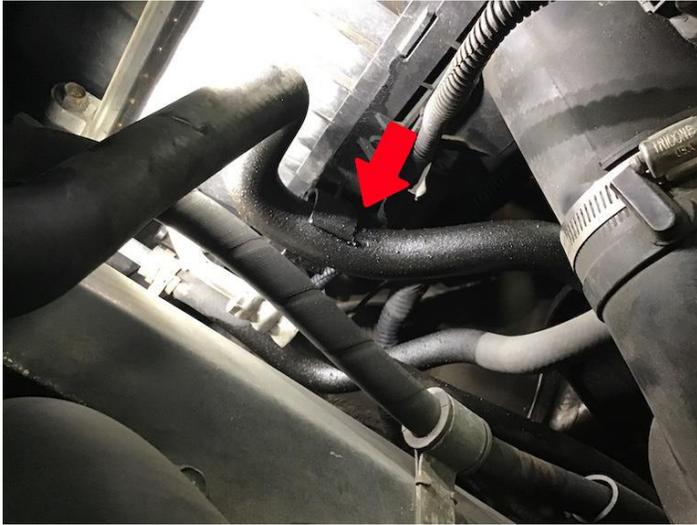
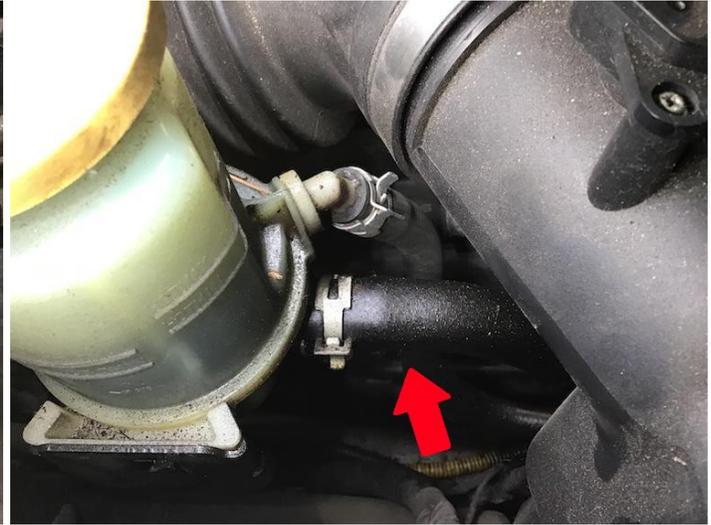
Power Steering Fluid Condition
Damp return line, pump to reservoir.

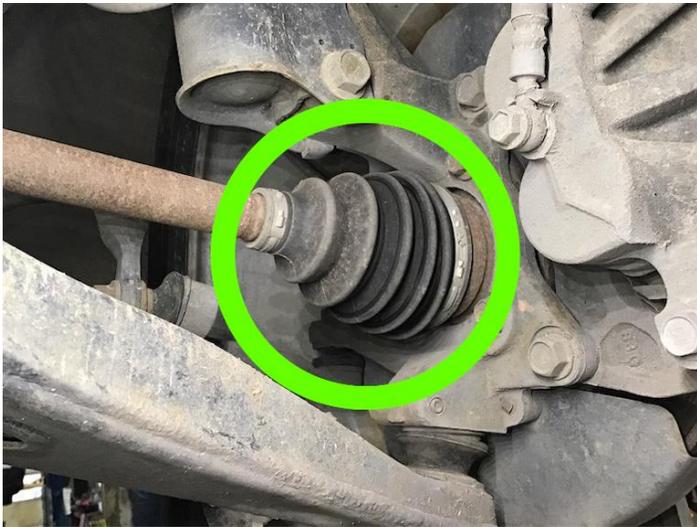
This is one of your axle boots we took a photo of. All of your protective axle boots are in good condition

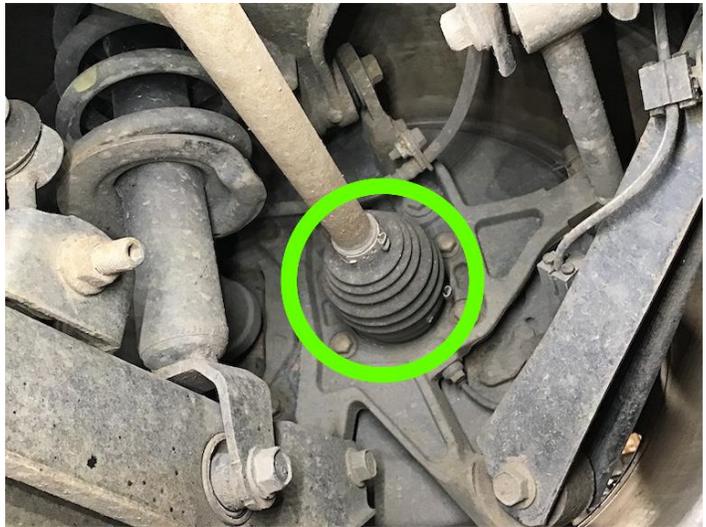
This is another one of your axle boots, they are in good condition at this time

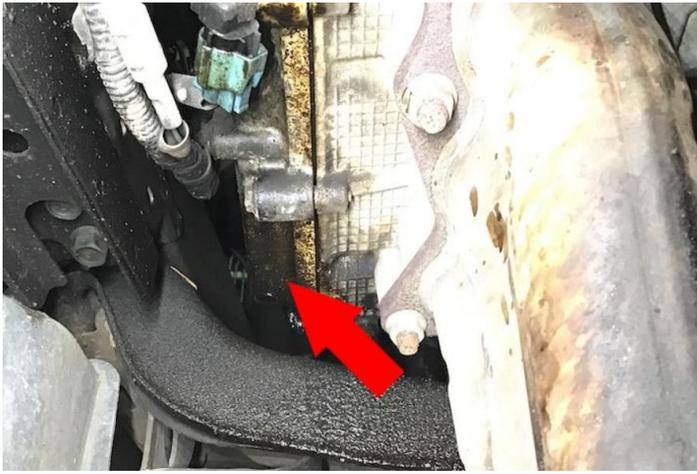
Engine Oil Leak
Valve cover gasket.

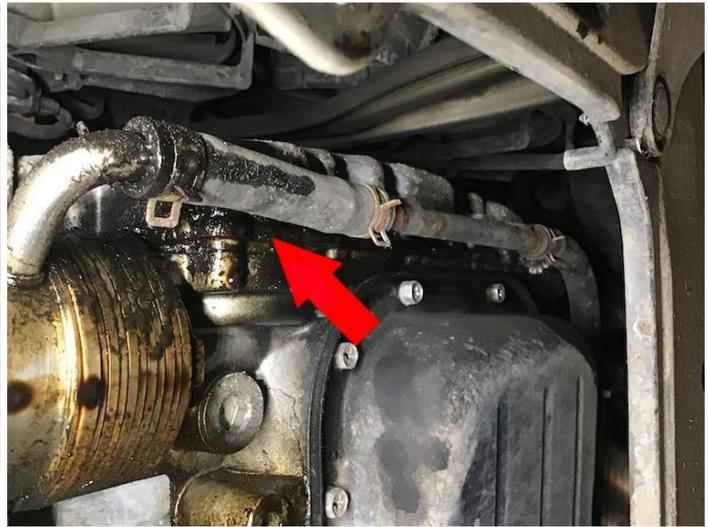
Engine Oil Leak
Timing chain case.
